PRELIMINARY ASSESSMENT REPORT

LANE STREET GROUND WATER CONTAMINATION

ELKHART, INDIANA

OCTOBER 5, 2007

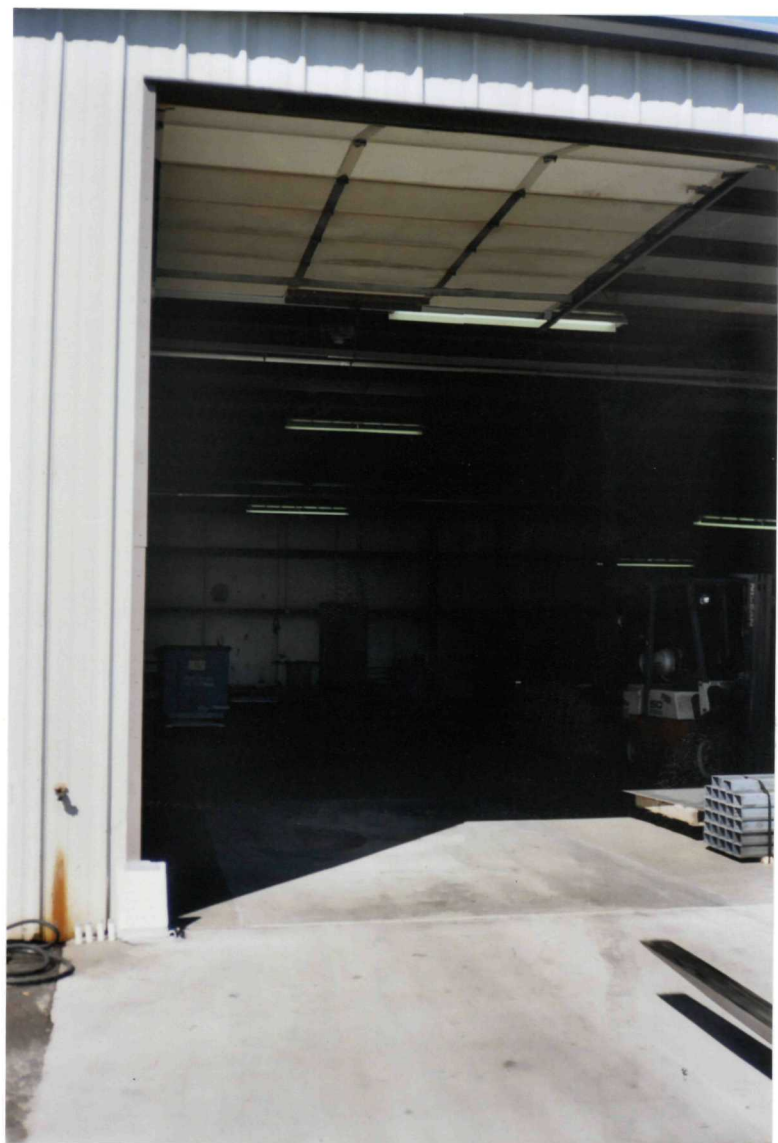
SITE: Lane Street Ground Water Contamination  
EPA ID#: INN000510229  
DATE:8/31/07  
TIME: 11:20 am  
WEATHER: Sunny; 80s °  
SAMPLE ID# LQ 4577  
SAMPLE TYPE: Ground Water  
DESCRIPTION: Ground water sample obtained from 23537 CR 106

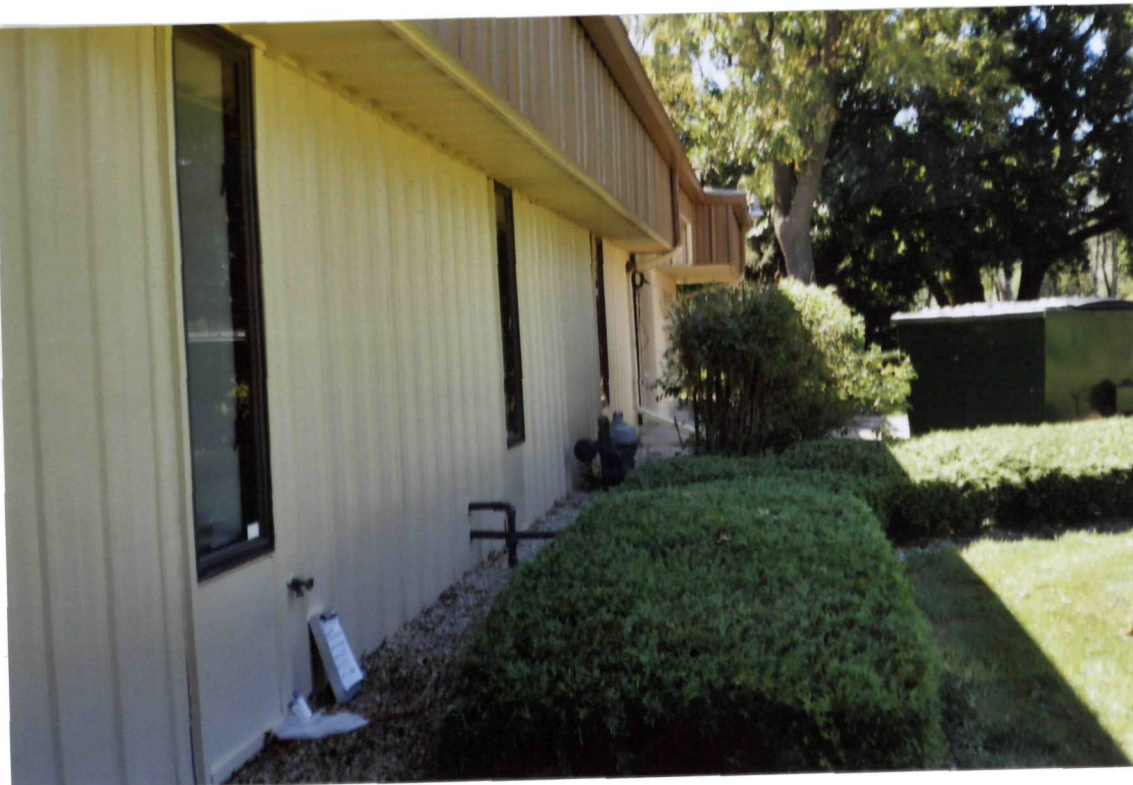
SITE: Lane Street Ground Water Contamination  
EPA ID#: INN000510229  
DATE: 8/31/07  
TIME: 11:55 am  
WEATHER: Sunny; 80s °  
SAMPLE ID# LQ 4578  
SAMPLE TYPE: Ground Water  
DESCRIPTION: Ground water sample obtained from 53465 Ada

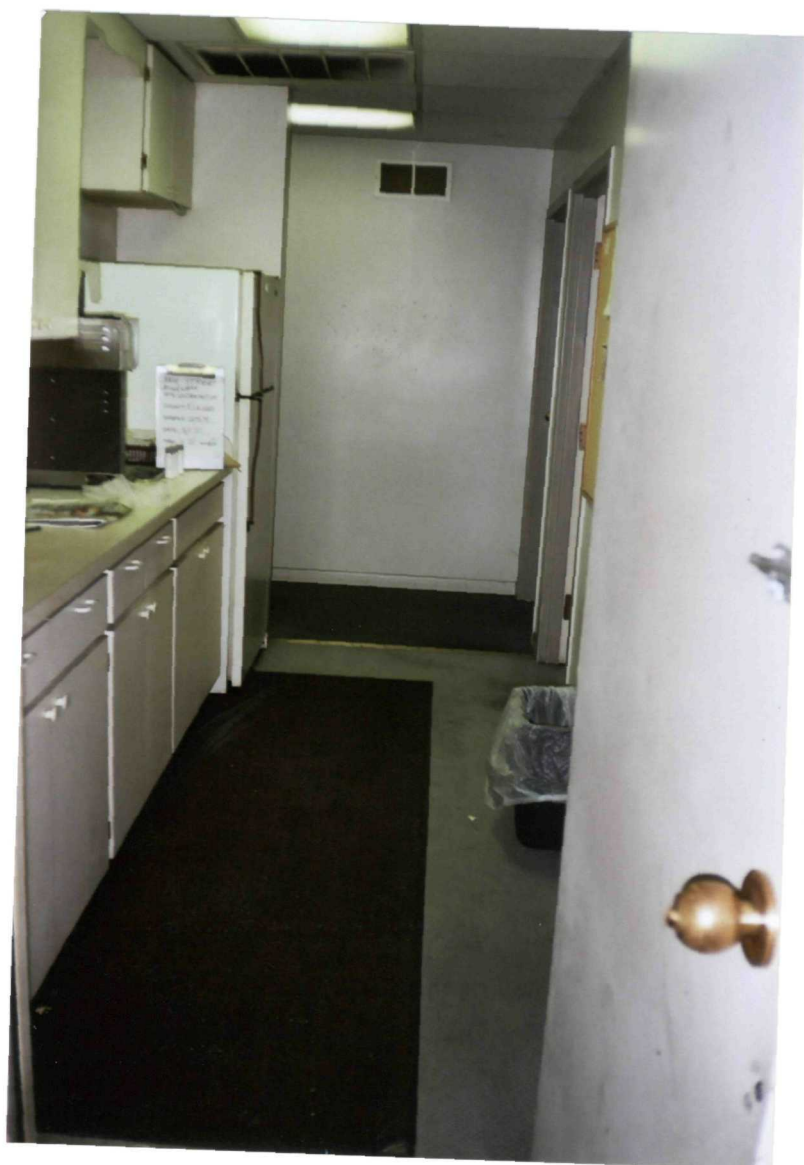
SITE: Lane Street Ground Water Contamination  
EPA ID#: INN000510229  
DATE: 8/31/07  
TIME: 12:25 am  
WEATHER: Sunny; 80s °  
SAMPLE ID# LQ 4579  
SAMPLE TYPE: Ground Water  
DESCRIPTION: Ground water sample obtained from 53468 Ada
